# BELZONA OFFERS THE KEYWAY TO SUCCESS

ID: 5337

Large punch press keyway.

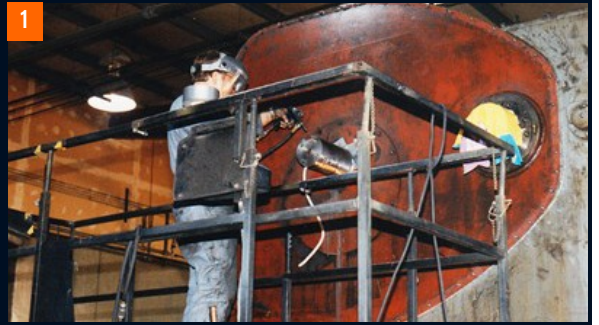
1. Punch press, blasting the keyway
2. Before sheave removal, showing damage to the keyways
3. Forming the sheave keyway
4. Forming the shaft keyway

Both halves of the keyway were worn, but the shaft was worn more than the sheave. The keyway was grit blasted for maximum bonding. The sheave side was formed first then the shaft was formed, using the sheave to center the new keyway. The application was carried out in accordance with Belzona Know-How System Leaflet MPT-4.

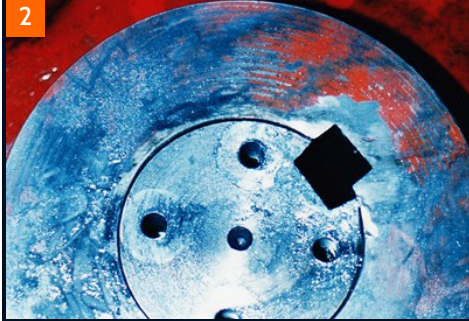
The keyway on this large punch press had been pounded oversize front, with a back and forth action ending in a hard stop each way.
