# BELZONA: SWEET SUCCESS FOR CHOCOLATE MANUFACTURER

ID: 534

Granite lining (35-mm thick) on a chocolate mixing vessel.

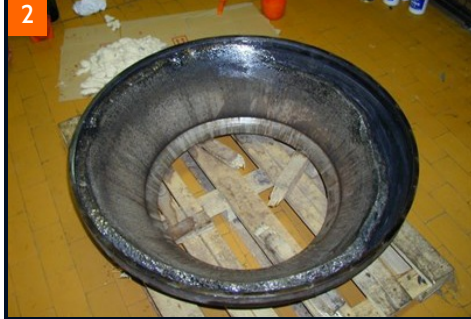
Damaged lining caused by impact through years of service.

1. Close-up of damaged lining
2. Mechanically prepared surface ready for Belzona
3. Completed application
4. Close-up of repaired lining detail
