# BELZONA IMPROVES PUMP EFFICIENCY

ID: 5341

Multi-stage water pump.

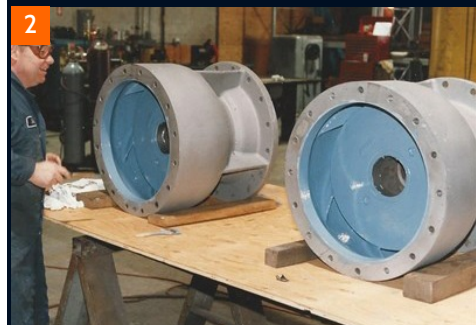
1. Completed application on impeller
2. Completed application on casing
3. Completed application on casing
4. View of completed application on water pumps

The pump casings and impellers were grit blasted and then two coats of Belzona 1341 were applied. The application was carried out in accordance with Belzona Know-How System Leaflets CEP-10.
