# BELZONA EXTENDS THE LIFE OF THE SHAFT

ID: 5343

Coke shaker keyway.

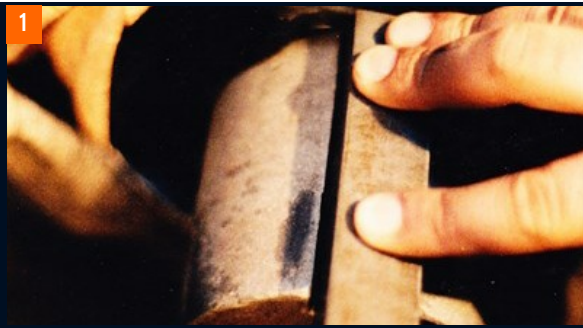
The shafts in this coke shaker really take a beating. It was believed that the keyway was machined oversize by mistake. The sheave was also loose on the shaft.

1. Showing the wear on one side of the keyway
2. Key in place and Belzona 1111 on the shaft
3. Completed application and equipment reassembled, ready to shake
