# BELZONA SAVES TIME BY REBUILDING SHAFT

ID: 5344

Belt drive shaft on a street sweeper.

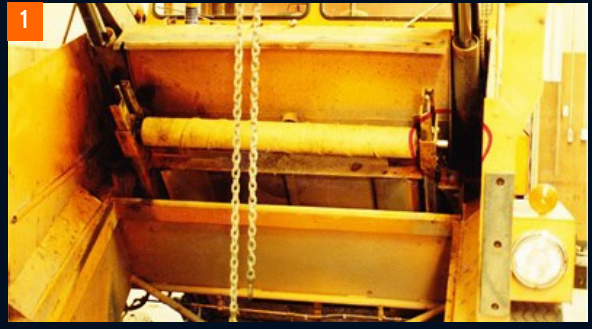
A seized bearing damaged the shaft.

1. Location of worn shaft on street sweeper
2. Shaft mounted in lathe, rebuilt with Belzona 1111
3. Completed application to rebuild shaft, ready to be reinstalled
