# BELZONA PROVIDES SAVINGS BY SEALING FLOOR

ID: 5349

## PROBLEM

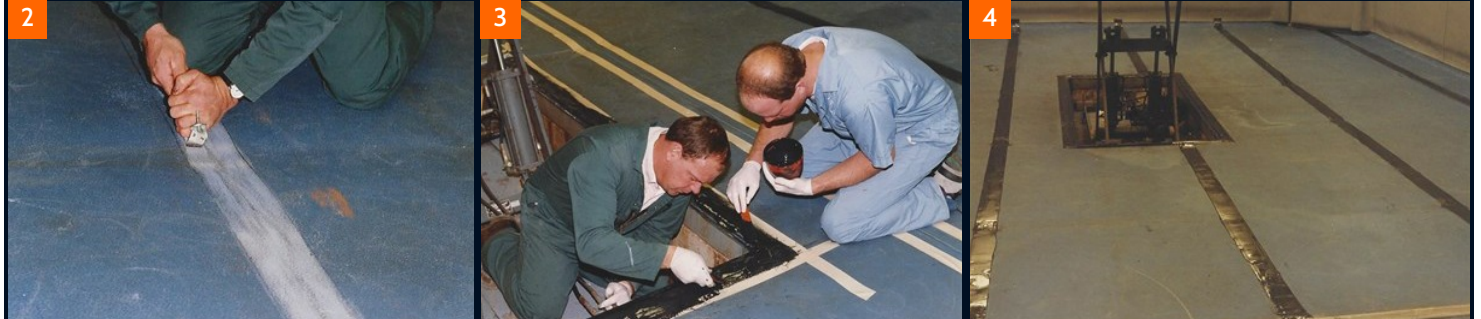
## PHOTOS

The seams on the floor in the large animal surgery room had split open, allowing bacteria to flourish underneath. The floor had to be sealed.

1. Drying the floor after cleaning
2. Abrading the surface
3. Applying Belzona 2221 over the seams
4. Completed application

The floor was cleaned and disinfected, and then allowed to dry. A roughing tool was used to abrade the surface. Belzona 2911 was applied and allowed to cure. The area was masked off and Belzona 2221 was brushed on with Belzona 9341 to bridge the seam. The application was carried out in accordance with a modified version of Belzona Know-How System Leaflet FPA-6.
