# RIG BALLAST SYSTEM REPAIRED WITH BELZONA

ID: 535

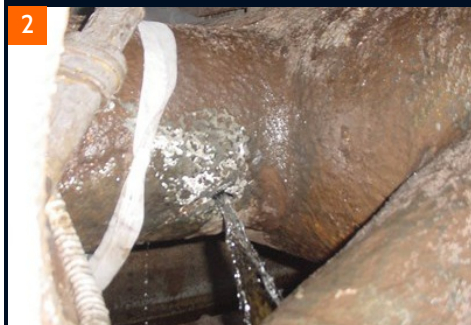
Severely corroded and leaking pipes in many sections of the ballast system which threaten the safety of the rig.

1. General view of the rig
2. Leakage of the ballast pipes of the rig
3. Repair completed
4. Another repair

Belzona 1121 (Super XL-Metal)  
Belzona 1291 (ES Metal)
