# BELZONA REPAIRS AND PROTECTS CHIPPER DISC POCKETS

ID: 5351

Plywood mill core chipper disc.

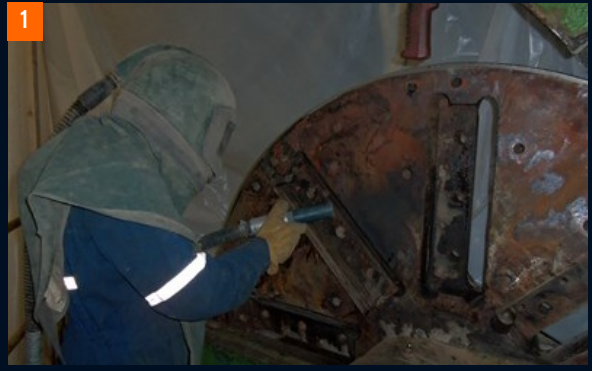
Excessive wear in the chipper disc pockets was damaging the chips.

1. Grit blasting the chipper disc pockets
2. Pocket ready for application of Belzona 1811
3. Pocket from front side showing counter knife in place, Belzona 1811 in the pocket
4. Smoothing Belzona 1811 with soap and water to prevent chips from sticking

The chipper disc pockets were sweated and grit blasted in place. Belzona 9411 was brushed onto the new counter knives. The counter knives were installed and Belzona 1811 was applied in the pockets. After a partial cure, water mixed with dish soap was used to smooth the surface so the wood chips would not clog the pockets. The application was carried out in accordance with Belzona Know-How System Leaflet SHM-13.
