# BELZONA PROTECTS STERN TUBE

ID: 5353

Stern tube in a US Army Ship.

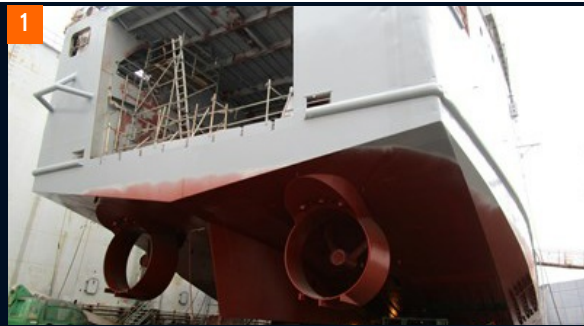
1. Stern of the ship
2. Inspecting the grit blast
3. First coat of black Belzona 5811
4. Second coat of gray Belzona 5811
