# BELZONA SAVES TUG BOAT COMPANY \$200,000+

ID: 5354

While in dry dock, it was found that the lower half of the port and starboard Kort nozzle drive assemblies had severe erosion on the propeller side of the housing.

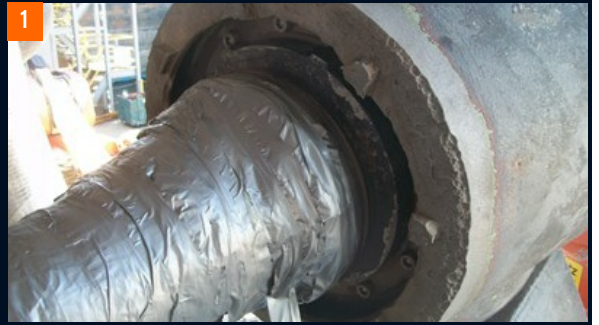
1. Eroded housing
2. Belzona 1311 applied and the former installed
3. Repair completed
4. The Port and Starboard Kort nozzles and drive assemblies shown while the tug is in dry dock
