# BELZONA REPAIRS HOLES IN US NAVY SHIP

ID: 5355

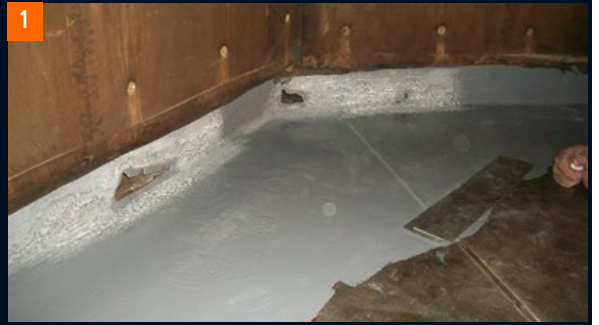
The bulkhead in the intake plenum has holes rusted through the steel.

1. Three holes are shown in the intake plenum. Two large and one small.
2. A thorough grinding of the bulkhead and the steel plates is completed.
3. The completed repair is shown. Belzona 1111 was used to bond the plates over the holes.
