# WATER PUMPS REPAIRED AT HISTORIC RESERVOIR

ID: 5357

Queen Mary Reservoir, Surrey

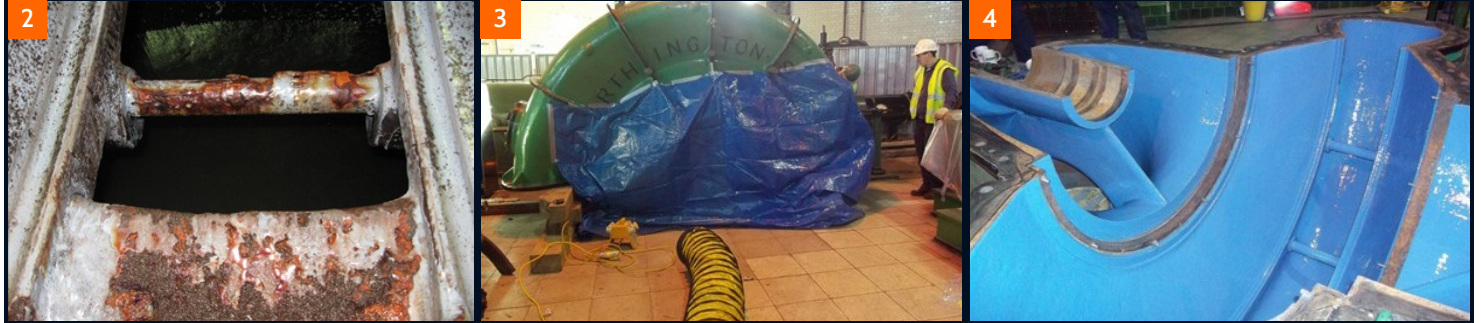
## PHOTOS

After years of frequent use, certain areas of the pumping equipment were suffering from cavitation damage, which in turn was seriously hindering the efficiency of the pumping system.

Damaged pump volutes, totalling a surface area of 282m<sup>2</sup>.

1. Pump casing prior to removal of existing coating
2. Pump casing severely corroded
3. Sponge blasting in progress
4. Completed application

Application carried out in accordance with a modified version of Belzona Know-How System Leaflet CEP-3. Firstly, Sponge Blasting equipment was used on the upper and lower casings to remove the previous coating and create a cleanliness of at least SA 2 ½ and produce a surface profile of no less than 75µm. Due to the extent of the damage, (some areas of each volute exhibited up to 50% corrosion) complete metal repairs were prescribed using Belzona 1111 followed by a protective coating of Belzona 1341.
