# BELZONA REPAIRS PURGE TANK

ID: 5358

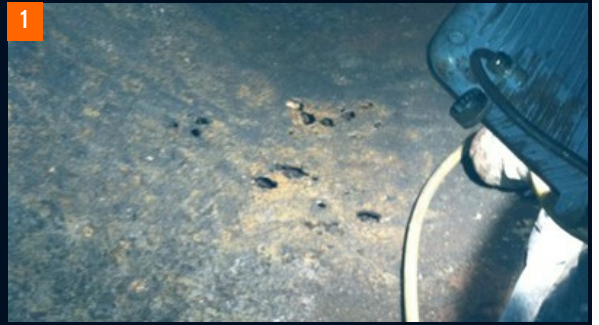
A purge tank was getting corroded to the point that hot water was seeping through small holes in the tank. Leakage and safety were a great concern.

1. Condition of the tank
2. Tank after grit-blasting
3. Bonding metal patches using Belzona 1511
4. View of the tank after two coats of Belzona 5892
