# BELZONA REPAIRS NAVY VALVE

ID: 5359

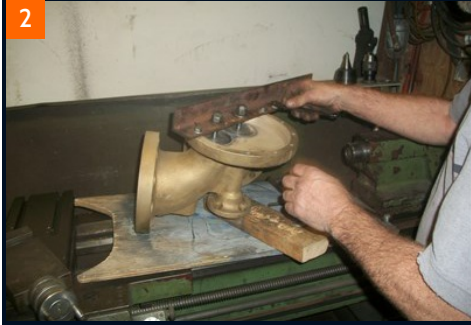
The bronze substrate had eroded in the valve seating area to the point where the rubber O-ring could no longer seal.

1. Bronze valve casing eroded in the seat O-ring area
2. Formers seated in Belzona 1111 to mold a smooth oil seal surface
3. Newly molded O-ring surfaces. Also, a new valve seat with O-ring is shown as well
4. Left newly molded area with the excess of Belzona 1111 filed away using round rasp files

The bronze valve housing was blasted to a near white metal finish. Dummy valve seats were manufactured and coated with Belzona 9411 to serve as formers. Belzona 1111 was applied to the blasted housing and to the formers. The formers were seated into the fresh Belzona 1111. Several hours later the formers were removed and the excess of Belzona 1111 was removed using coarse files.
