# BELZONA REPAIRS STEERING GEAR

Severe corrosion on the affected areas of the rudder stock and pintle housing areas.

Rudder stock - upper housing and pintle housing.

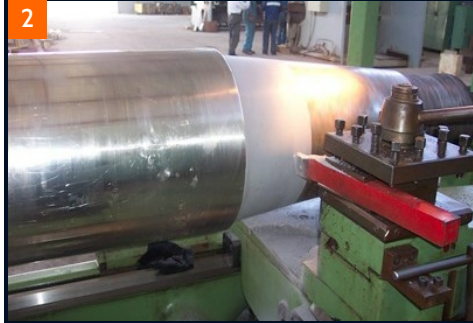
1. General view of the cargo ship.
2. Rudder stock being machined back to its dimensions after repair.
3. Belzona 1121 was applied to both pintle and pintle housing.
4. Rudder being installed.
