# BELZONA EXTENDS THE LIFE OF HYDRAULIC RAMS

ID: 5364

Plywood press with scored hydraulic rams.

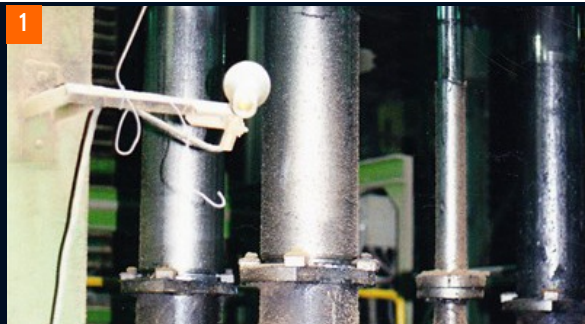
Three hydraulic rams had been scored and the loss of oil was so bad that they had built a dam so the oil would drain into a 55 gallon drum. At the end of each shift the oil was pumped back into the reservoir. They had tried repairing the score with another material, but it fell off after one pass.

1. Plywood press showing damaged hydraulic rams
2. Rams repaired
3. Close up of one repaired ram
