# BELZONA REBUILDS PUMP IMPELLER

ID: 5365

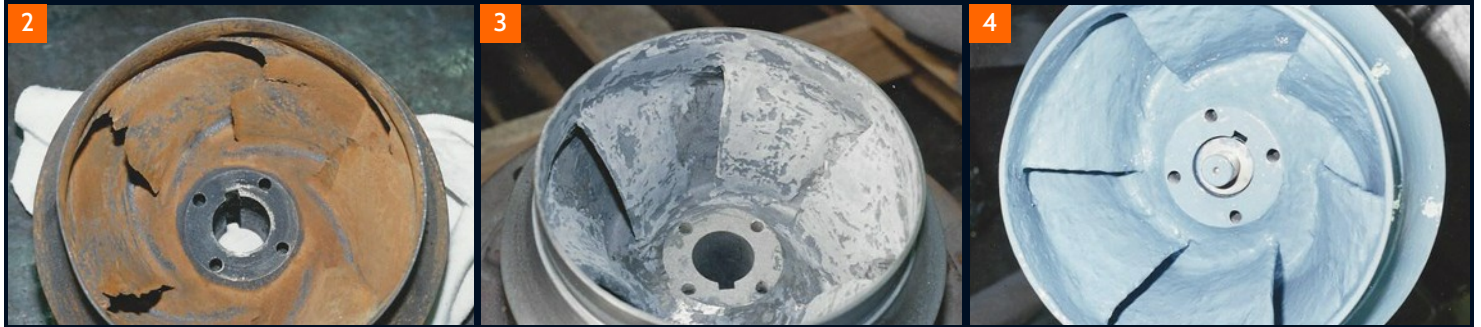
The pump had become worn beyond repair and was thus tossed in a scrap pile.

1. Damaged impeller showing holes
2. Worn impeller vanes
3. Impeller rebuilt with Belzona 1311
4. Completed application with two coats of Belzona 1341

The application was carried out in accordance with Belzona Know-How System Leaflets CEP 1 & CEP 3. Holes and impeller vanes were patched with Belzona 1311 and a reinforcing sheet. The high spots were ground down to smooth the surface and Belzona 1341 was brushed on in two coats.
