# BELZONA REPAIRS FAN BLADES

ID: 5369

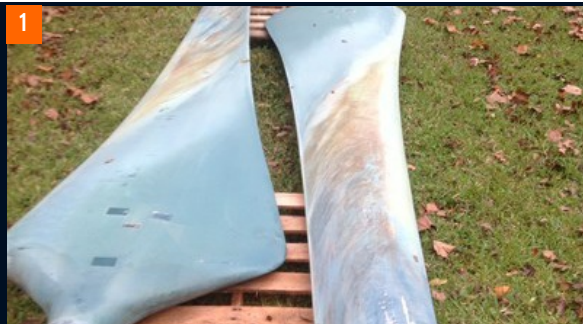
Fan blades on cooling tower seeing wear on leading edges reducing efficiency.

1. Damaged blades before the repair
2. Leading edges repaired
3. Application completed

The application was carried out in accordance to Belzona Know-How System Leaflet FBC-1. Belzona 1111 was used to rebuild the damaged area on the leading edge and Belzona 1321 was applied to the edge for erosion protection. The body of the blades were coated with Belzona 5811 and overcoated with Belzona 5111.
