# KEEPING THE PILOTS AFLOAT WITH BELZONA

ID: 537

Leaking fuel oil tank on board a harbour pilot transfer vessel.

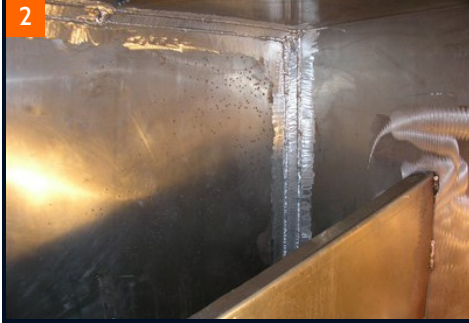
The folded and welded seams of the Aluminium tank had become porous, allowing diesel fuel to leak out.

1. The pilot vessel docked.
2. Preparation and detail of weld seam.
3. The Belzona being applied. The restricted working area is evident.
4. Detail of the finished repair.

Belzona was chosen as a means of providing an effective, long lasting repair. Alternatives would have been to try to weld the damaged areas but as it was the weld seams that were leaking and there was very tight access this was deemed impractical. There was also the contamination and presence of diesel to contend with which further ruled out the use of any hot work. The repair was carried out over the course of two days to allow for full curing of the material before pressure testing and then returning the vessel to service.
