# FORMING FLAT FLANGE FACES ON A VENTURI WITH BELZONA

ID: 5371

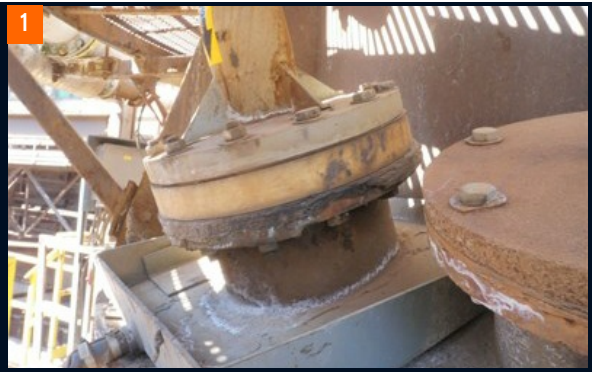
1. Flange on neighbouring unit in service; one year after rebuild, there is zero leakage in any of the 10 repaired flanges. Note the catch basin under the flange; the Belzona repair has made these redundant and they are being removed. Original trial flange is still in excellent condition after two years in service.
2. Forming plate clamped in place, with plastic pipe used to form bolt holes.
3. Perfectly flat rebuilt surface seats the gasket properly and does not leak.

Belzona 2111 is applied to the prepared and conditioned surface; Belzona 2121 is applied to a flat metal forming plate (already coated with Belzona 9411), and this plate is clamped into position with plugs inserted into bolt holes. When the plate is later removed, a perfectly flat gasket surface remains. The application was carried out in accordance with Belzona Know-How System Leaflet GSS-1.
