# BELZONA STOPS LUBE LEAKS

ID: 5373

Concrete wall leaking lube oil

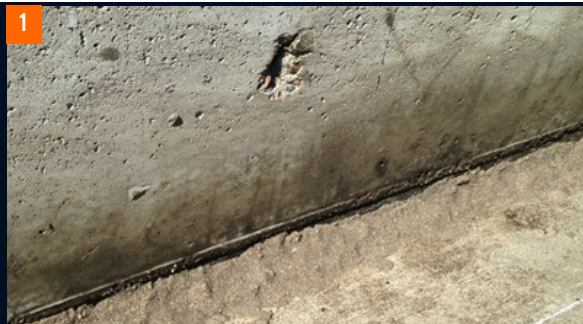
The customer stored lube oil within a small containment area, when leaks would develop they would by-pass and go under the wall onto the ground outside of the containment area.

1. Before repair
2. During repair
3. Application completed
