# BELZONA REPAIRS A VACUUM PUMP

ID: 5375

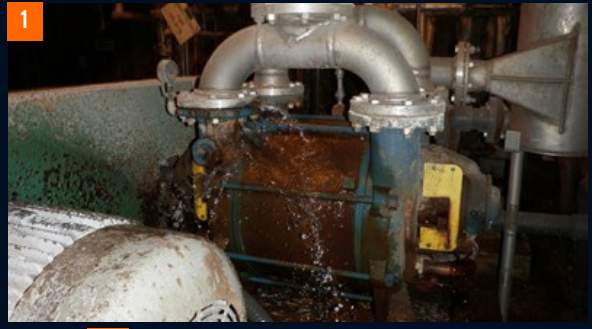
The outlet port had corroded to the point a hole had formed; a competitor's patch product had been applied but failed after a short time.

1. Image of the leak
2. The surface preparation requires a number of tools due to the tight space
3. Exposed hole is a bit larger than expected
4. The application complete
