# BELZONA REPAIRS CRUDE OIL LEAKS

ID: 5376

Pinhole leak at weld on a crude oil line.

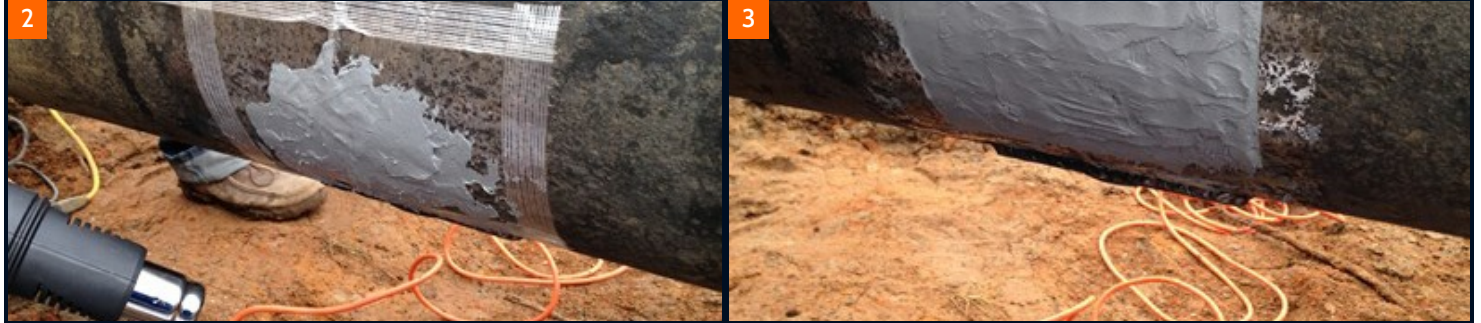
After testing a newly installed line, the customer found a pinhole leak at a weld. Hot work was not permitted because crude oil was now in the line.

1. Cleaning of the immediate area
2. Belzona 1221 was used to stop leak
3. Belzona 1161 used to encapsulate for long term protection

The application was carried out using a modified version of Belzona Know-How System Leaflet VPF-11. Belzona 1221 was used to stop the immediate leak. The area surrounding the leak was then prepared and Belzona 1161 was applied for long term protection.
