# BELZONA WORKS WHEN THE HEAT IS ON

ID: 5379

Leaks had formed around a set of plates used to support cooling coils where they pass through the wall of the roaster.

The wall of a fluidized bed roaster where zinc ore concentrate is burned to create zinc oxide.

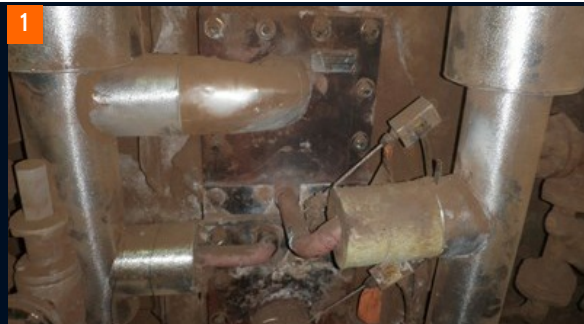
1. Insulation stripped to expose the area; the plates vary from 200°F to 330°F and the exposed piping is over 450°F. 2. The leak is coming from behind the center plate, especially the end at the LH side. 3. Completed application; the center plate is sealed. Please note the Belzona product on the left end of the plate where a bolt was inserted and extra material was required to seal this live leak of hot SO<sub>2</sub> gas.

The gap between two of the plates was sealed using Belzona 1251. The area to be repaired was cleaned with a hand-held wire brush. Then, Belzona 1251 was applied with a metal spatula onto the hot surface (temperature varied from 200°F to 330°F depending on location). In the area of the worst leak, Belzona 1251 was applied to reduce the hole size to approximately ¼" and a small bolt was then packed with Belzona 1251 and inserted. The bolt head was then covered with a cap formed of thin metal sheet, filled with Belzona 1251, and held in place until the product set. This repair was performed with the unit active and specialized PPE was worn accordingly. The application was carried out in accordance with a modified version of Belzona Know-How System Leaflet HEX-5.
