# BELZONA REPAIRS TO CEMENT FAN SHAFT

ID: 538

Cement fan shaft

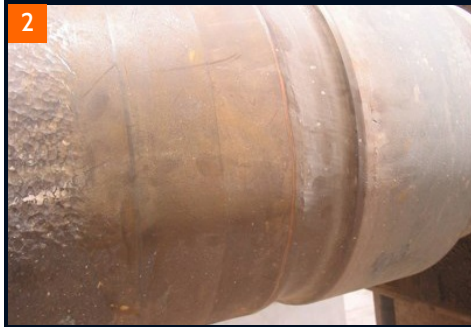
1. General view of the fan shaft
2. The worn out shaft
3. Form was applied
4. Application was completed

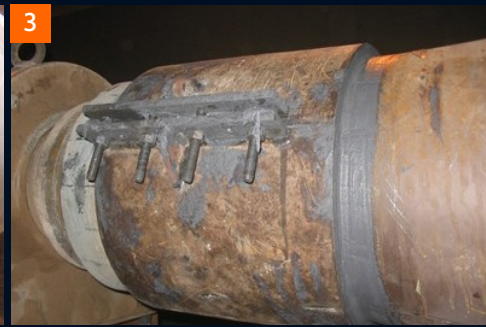
Deeply worn shaft due to abrasion from cement - leading to potential bearing failure.

The dimension of the shaft was restored and the repair was completed without machining. A conventional repair method to repair this shaft was not a favorable option due to the high costs of welding and machining in addition to the large fan that cannot be separated from the shaft.
