# BELZONA ENCAPSULATES A TRANSFORMER FAUCET

ID: 5381

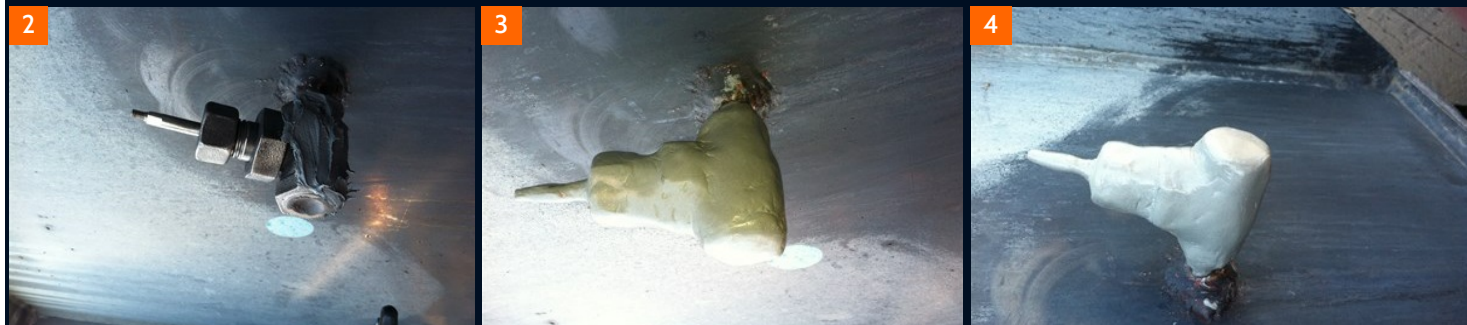
## PHOTOS

This leaking faucet was no longer needed, but in order to replace or plug it, the transformer would have to be taken off line and the entire 2000 gallons of oil would need to be drained resulting in lost revenue for this power company.

Leaking inspection faucet.

1. Prepared surface
2. Belzona 1291 applied in the end
3. Applying Belzona 1161
4. Application completed

The faucet was prepared with a grinder, then the active leak was stopped and sealed using Belzona 1291. Belzona 1161 was then used to encapsulate the entire faucet. Application was carried out in accordance with Belzona Know-How System Leaflet VPF-11.
