# BELZONA KEEPS A TRANSFORMER IN SERVICE

ID: 5382

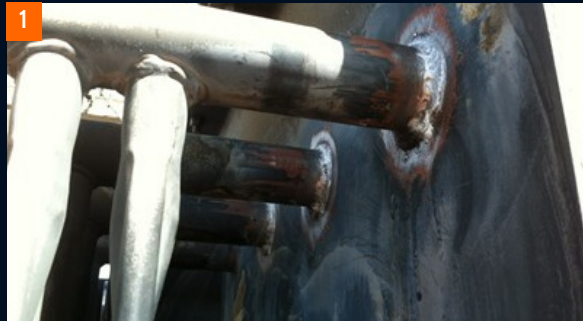
Welds on the circulation pipes of an electrical transformer were leaking oil, causing an environmental hazard, as well as a mechanical problem, and loss of oil which is essential to proper operation of transformers.

1. Leaking welds on the circulation pipes
2. Application completed

The application was carried out in accordance with a modified version of Belzona System Leaflet FBC-6. A grinder was used to prepare the surface, then Belzona 1161 was used to seal the seeping leak.
