# BELZONA FIXES BAD WELDS ON A TRANSFORMER

ID: 5383

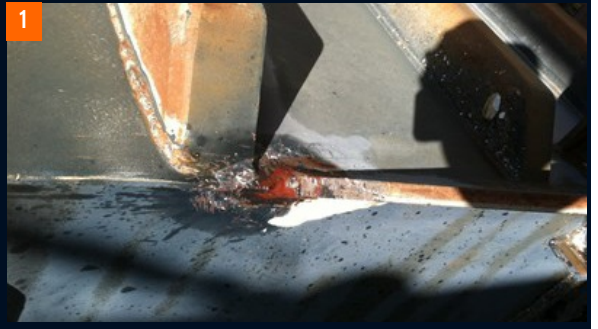
Corner bracket on an active electrical transformer was leaking oil.

1. View of the leaking weld
2. Side view of the leaking weld, including the oil stain surrounding the weld
3. Application completed

The surface was prepared using a coarse grit grinding wheel. The Belzona 1161 was applied according to the Instructions For Use. Application was carried out in accordance with a modified version of Belzona Know-How System Leaflet TCC-1.

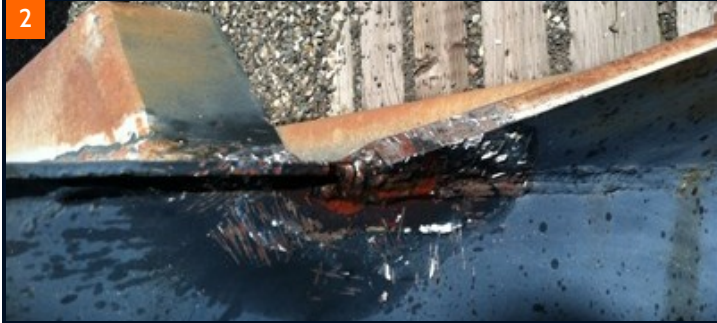
Leaking corner weld on an active transformer.
