# BELZONA REBUILDS RUDDER PINTLE HOUSING

ID: 5388

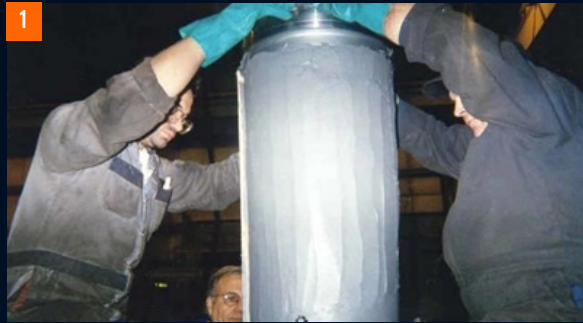
Rudder pintle housing was badly eroded /corroded and required rebuilding.

1. View of rudder pintle liberally coated with Belzona 1311.
2. Pintle fully inserted and centered using a jig tack welded to the top of the rudder.
3. Completed application. Note finish of newly formed bore.

Repairing the pintle housing using Belzona 1311 eliminates the probability of developing stress cracks and can be completed in less time. The repair also eliminates the possibility of bi-metallic corrosion taking hold again as it isolates the two metals present in the housing assembly.
