# BELZONA SUCESSFULLY REPAIRS VACUUM PUMP

ID: 539

Vacuum pump

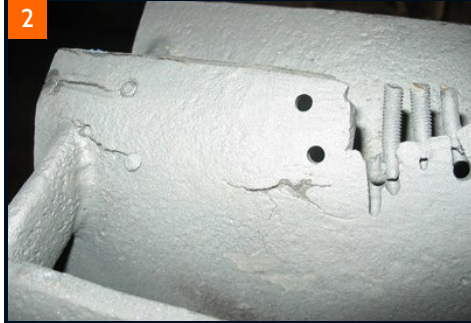
Eroded-corroded rotor and casing due to the effect of water, chemicals and limestone. The vanes of the rotor were cracked and fractured in many places.

1. The eroded-corroded rotor
2. Repairs to cracks and fractures in the vanes of the rotor
3. Rotor after repairing and coating.
4. Casing after repairing and coating
