# BELZONA REPAIRS AND PROTECTS HOUSING

ID: 5395

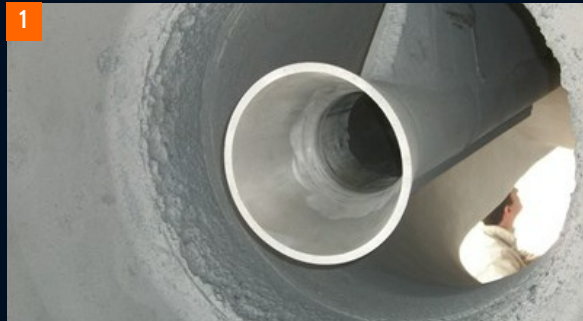
Erosion and corrosion caused a major loss of metal in the jet drive transom housing.

1. Blasted port transom housing
2. Mold is in place and the Belzona rebuilding metal is being applied to return the housing to the original dimensions and contours
3. The completed port transom coated with Belzona 1321. The molded jet drive clearances are perfect
4. Stern view of the Special Operations Craft and the transoms (covered by tarps)

The transom housing was blasted to a near white metal finish. A former was manufactured to mold the critical clearances to 1-2 mm between the removable jet drive and the boat transom housing. Once the rebuilding and molding was completed, two coats of Belzona 1321 were applied.
