# LEAK-FREE SKYLIGHTS WITH BELZONA!

ID: 5396

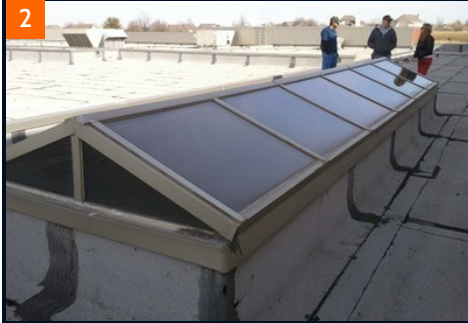
Poorly engineered rooftop skylight(s) leaking into the main hallway and traditional roof repairs failed.

1. Consultant and School Official discussing the project in the main hallway directly below the leaking skylight.
2. Picture of a leaking skylight
3. Application of conditioner prior to meshing the seams
4. Completed repair with Belzona 3111 applied to the seams, flashing and glazing
