# BELZONA REPAIRS AND PROTECTS ROOF FROM LEAKS

ID: 5397

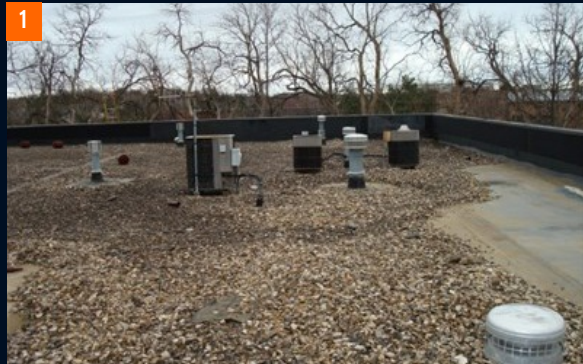
All five roofs of this commercial business park had numerous water leaks and interior water damage.

1. Overview of the roof
2. Areas to be treated
3. Belzona 3111 applied to designated areas, including possible penetrations throughout
4. Completed applications, including the seams of the entire perimeter
