# BELZONA IMPROVES WORKING CONDITIONS BY SEALING THE ROOF OF A CHOCOLATE FACTORY

ID: 5398

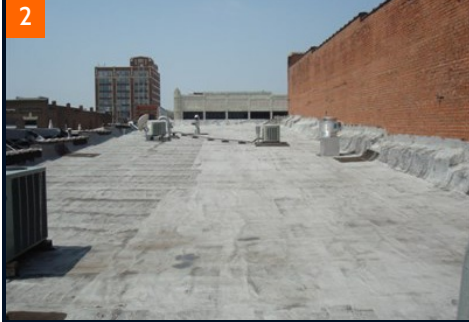
1. Storefront image
2. The roof prepared and ready for application
3. Picture of the first 1/2 of sprayed Belzona 3111
4. Picture of finished installation of Belzona 3111, including repaired parapets

The roof was pressure washed and the parapets were re-pointed with Belzona 4111. The roof was then completely sealed and protected with the Belzona 3111 system. The application was carried out in accordance with a modified version of Belzona System Leaflet RPA-10.
