# BELZONA WATERPROOFS FLASHINGS SAVING MILLIONS OF DOLLARS OF PRODUCT

ID: 5399

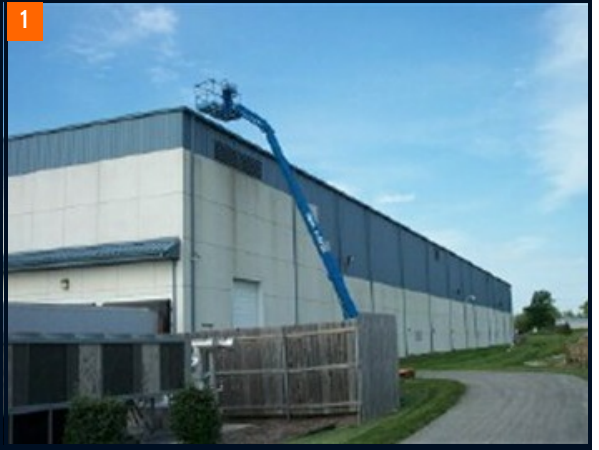
1. Picture of Warehouse/Storage Structure
2. Picture of the damaged flashing in need of repair
3. Close-up of Belzona application
4. Completed Belzona repair of 80 linear feet of flashing

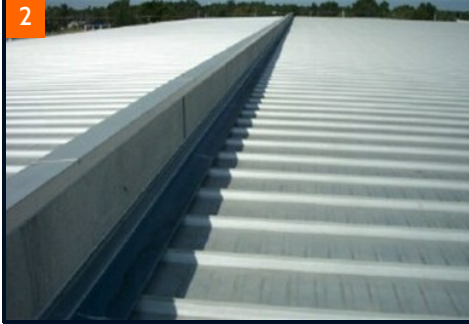
The material used to seal the flashings on this firewall had become brittle and cracked, creating fissures for water to seep into the building. A solution was needed that was both flexible and UV stable to protect this pharmaceutical storage facility housing millions of dollars of product.

The application was carried out in accordance with Belzona Know-How System Leaflet RPA-8 using the fully reinforced Belzona 3111 system.

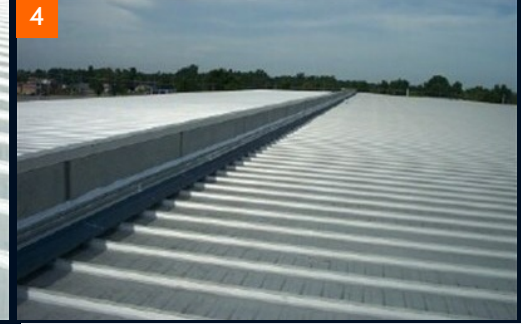
Due to past success with roof repairs for this pharmaceutical facility, Belzona was the confident choice. 850 linear feet of flashing was completely sealed and protected in two days. Inspected in 2012, the repair is still perfect.
