# BELZONA REBUILDS AND PROTECTS SEVERELY CORRODED PUMP

ID: 540

Main circulating water pump.

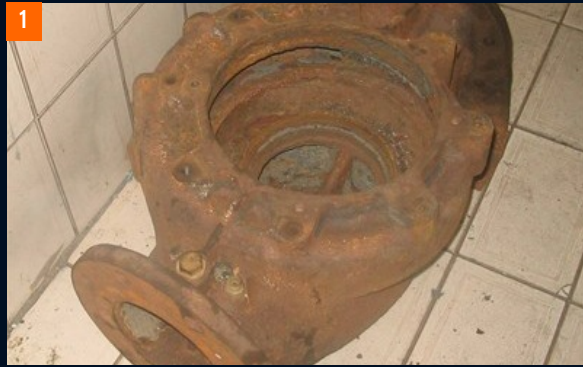
Severe corrosion and erosion inside the pump that led to many holes in the pump casing.

1. General view of the corroded pump
2. The pump from inside before repair
3. Rebuilding the worn out part of the pump after repairing the holed areas
4. Belzona 1321 was applied to protect the pump
