# BELZONA STOPS WATER DAMAGE TO AN OFFICE BUILDING

ID: 5400

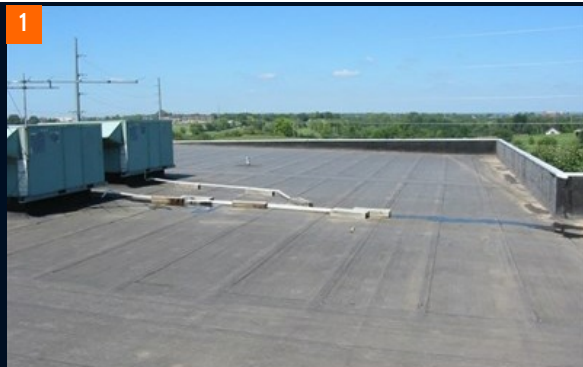
The roof of this Customer Service Building was leaking, causing water damage to interior ceilings, walls, and expensive office equipment. Stop gap methods had failed and Belzona was chosen because of reputation and competitive pricing.

1. View of the roof
2. Roof is prepared, conditioned & reinforcement done where needed
3. Belzona application commencing
4. Belzona application completed
