# BELZONA PROTECTS RUDDERS

ID: 5401

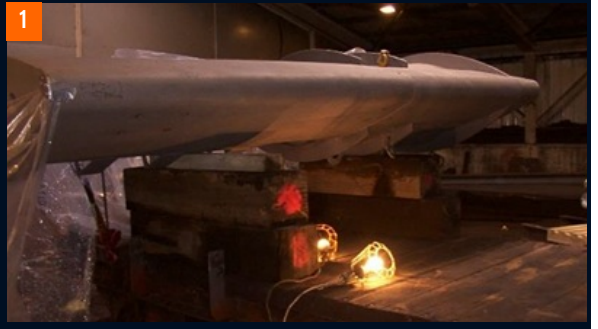
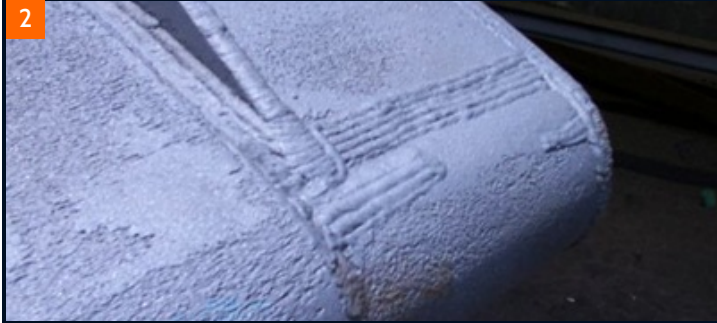
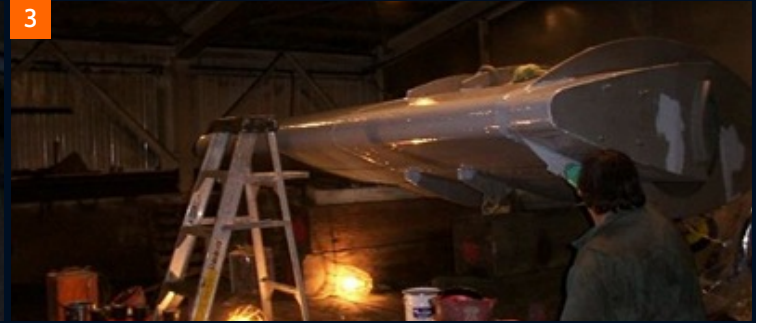
## PHOTOS

The rudders suffer from serious cavitation problems.

1. Rudder after grit blasting 2. Excessively cavitated areas are rebuilt with Belzona 1311 before being over coated with Belzona 1341 Supermetalgilde. 3. Final coat of Belzona 1341 Supermetalgilde (Grey) applied and force cured with heat lamps to meet deadline.

Application carried out in accordance with Belzona Know-How System Leaflet SOS 1,2

Application of Belzona 1341 Supermetalgilde will help reduce the effects of cavitation between dry dockings.
