# BELZONA STOPS WATER LEAKING INTO AIRCRAFT HANGAR

ID: 5402

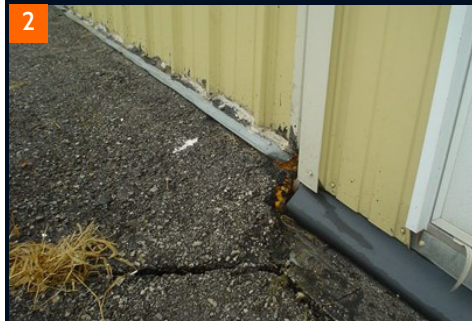
This hangar at a municipal airport was leaking water into aircraft hangars due to the damaged flashing and creating a slip hazard near the entry door. Mastics and caulk had failed and a more permanent solution was needed.

Damaged outer wall flashing of an airplane hangar.

1. Picture of airplane hangar
2. Damaged flashing and area of penetration
3. Berm built to direct water away from the door
4. Picture of completed repair

The flashing was re-secured to the asphalt with mechanical fasteners. Two coats of Belzona 3121 was then applied a few inches above the flashing and down onto the asphalt. Also, a small berm was fabricated with Belzona 4111 to divert run-off water away from the door.
