# BELZONA PROTECTS CONTAINMENT AREA AT A TREATMENT PLANT

ID: 5403

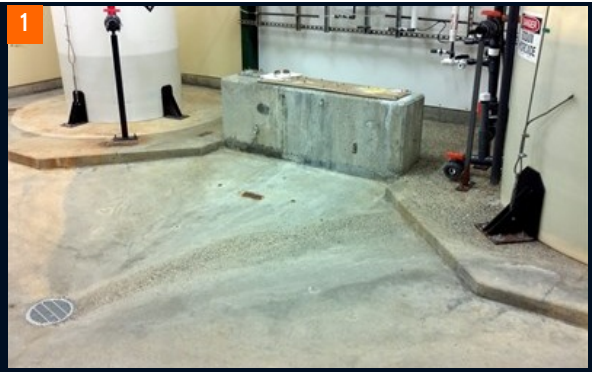
Spalled floor areas needed repair and coating to prevent further damage and provide secure containment for potential spillage. Treatment chemicals stored on concrete pads without protective coating including surrounding floor area and drain. Spalling to floor areas was evident where spillage occurred.

1. Wastewater plant chemical storage area before repairs & coating
2. Storage drain area spalling
3. Storage area after repairs & coating

The application was carried out in accordance with Belzona Know-How System Leaflets FPA-1, FPA-3. Belzona 4111 was hand troweled over most severely spalled areas prior to hand application of two coats of Belzona 5811.
