# BELZONA REFURBISHES A WASH PIT

ID: 5404

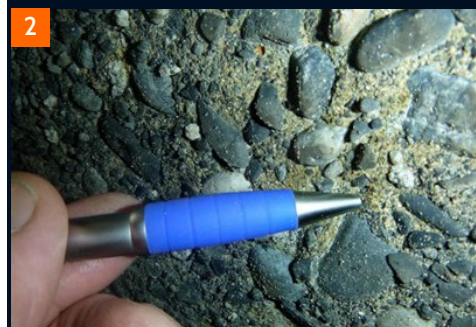
1. Wash pit overview
2. Erosion & spalling evident at waterline and below
3. Hand troweled application of Belzona 4111 over Belzona 4911 (Magma TX Conditioner)
4. Belzona 2211 applied into cable glands

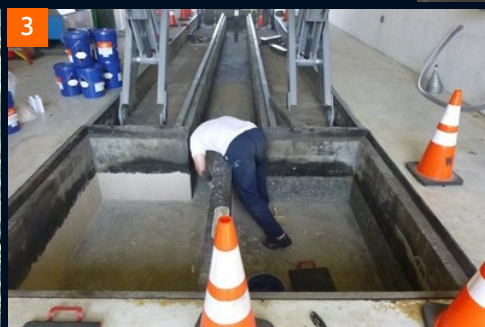
The structure had no previous coating and there was significant spalling at and below the waterline. Several electrical glands in the pit required resealing to prevent leakage into adjacent equipment vaults.

The application was carried out in accordance with Belzona Know-How System Leaflets FPA-1 and GSS-4. Thorough steam cleaning completed prior to hand troweling. Belzona 4111 was applied onto vertical sidewalls. Belzona 2211 was applied into pipe glands after cleaning and conditioning to prevent further leakage from wash pit into adjacent equipment vaults
