# BELZONA PROTECTS ASH SLURRY TANK

ID: 5405

Ash slurry tank

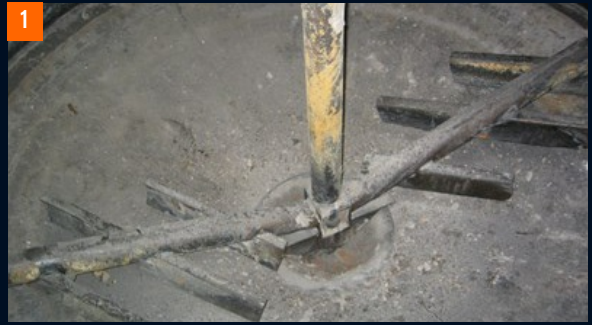
Customer looking for a proven coating to protect the life of their ash slurry tank. The tank receives solids in slurry at elevated temperatures from plant incinerator. Abrasion is noted problem with this component

1. Ash slurry tank before coating
2. Ash slurry tank during second coat application
3. Ash slurry tank after coating
4. Two years after above application

The application was carried out in accordance with Belzona Know-How System Leaflet TCC-3. Two heavy coats of Belzona 1321 were hand troweled and brushed onto all interior surfaces of tank and agitator.
