# BELZONA REPAIRS TIRE'S SIDEWALL

ID: 5406

Repair of the sidewall of a front loader and a large dump truck.

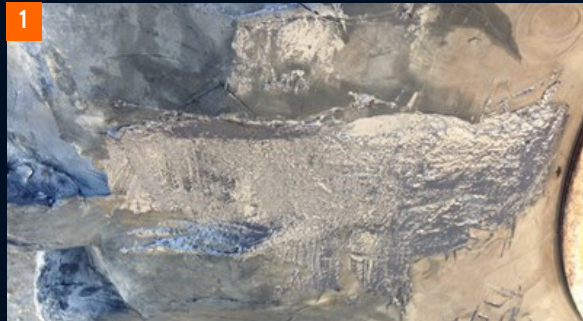
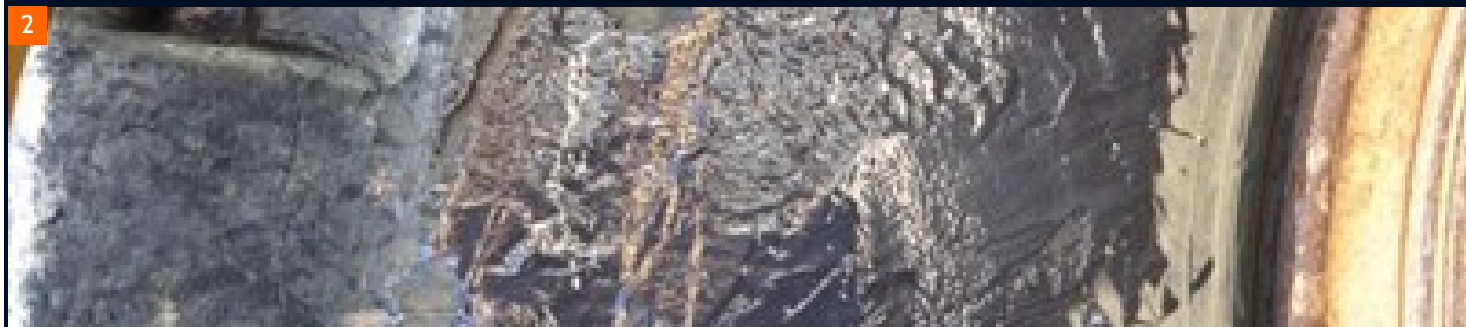
1. Completed application
2. Completed application

A tire of a front loader and a tire of a large dump truck had a cut in the sidewall rubber and a small chunk taken out of the sidewall, respectively. The tires would need to be replaced if there was no other alternative. They could remove the tire to be vulcanized, but that repair is costly and could take several days of downtime.

The surface area around the damage was prepared and roughened. The substrate was then conditioned with Belzona 2911. Once the conditioner dried, one coat of Belzona 2311 was applied around the damaged area. Then, Belzona 9341 was stippled before another coat of Belzona 2311 was applied.
