# SLIPPERY FLOOR DRAIN GETS BELZONA GRIP!

ID: 5407

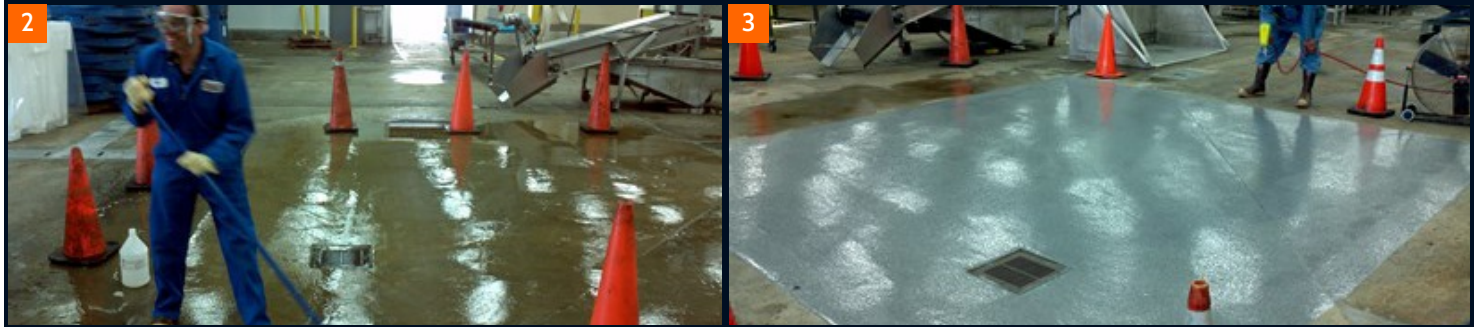
Concrete floor area around drain is very slippery with water & fish entrails. area sees both forklift and pedestrian traffic

1. Floor drain before the application
2. Thorough cleaning
3. Non-slip application of the floor drain is now complete

The application was carried out in accordance to Belzona Know-How System Leaflets FPA-3 and FPA-8. Concrete cleaned thoroughly and one heavy coat of Belzona 5811 applied to floor area. Belzona 9211 (Supergrip Aggregate) was then broadcast onto uncured material to create an aggressive non-slip surface.
