# BELZONA REPAIRS AND PROTECTS LEAKING FLANGE ON CHILLER

ID: 5408

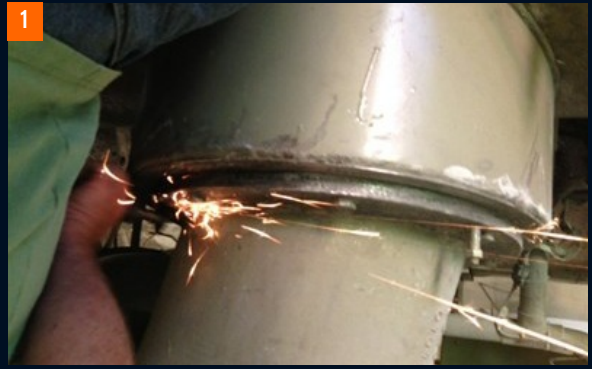
1. Surface preparation to roughen the substrate
2. Conditioning the substrate
3. Applying reinforcing cloth over Belzona 2121
4. Completed application

The surface was prepared with a grinder to roughen the substrate. Then, the application area was taped off. Belzona 2911 was applied to condition the substrate and allowed to dry. We then used Belzona 2121 in red and stippled in reinforcing cloth over the seam and bolts. We went over and applied a second coat of Belzona 2121 in black. We let it sit overnight and it stopped the leak.
