# BELZONA RESTORES LIFT STATION PUMP

ID: 5409

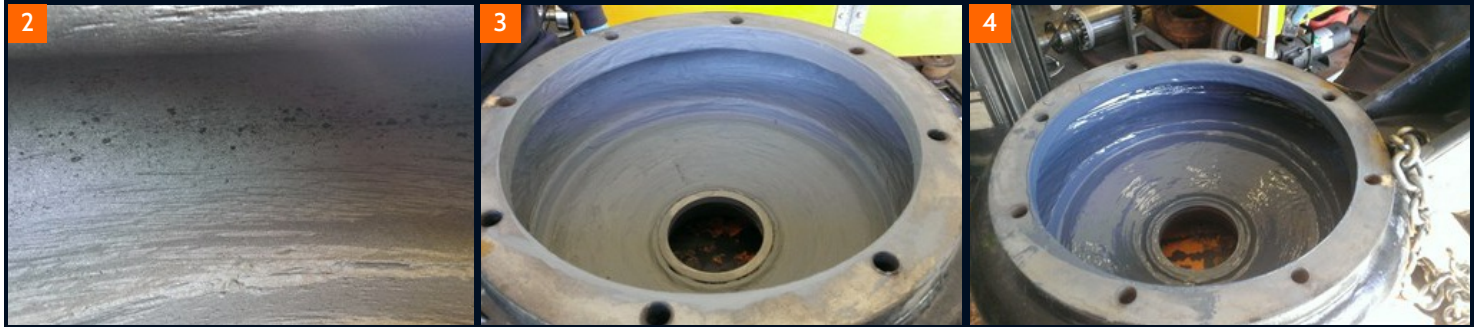
The suspected damaged pump was removed, disassembled and blasted to show the extent of erosion and cavitation.

The customer was experiencing noticeable vibration coupled with reduced pumping capacity.

1. Erosive wear in volute
2. Cavitation pockets evident
3. Belzona 1111 applied to fill the pockets and erosive wear
4. Overcoat with Belzona 1321

The application was carried out in accordance with Belzona Know-How System Leaflets CEP-3 and CEP-5. Eroded areas were rebuilt with Belzona 1111 and then coated with Belzona 1321. Both materials were applied by hand with the supplied applicators.

The pump has gone back into service without vibration problems and the pumping efficiency has been restored.
