# CIRCULATING WATER PUMP REPAIR

ID: 541

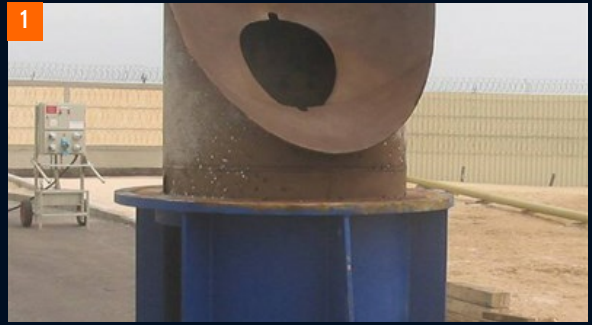
1. General view of the pump
2. The corroded discharge casing
3. Applying Belzona 1311 to the prepared surface
4. Application complete

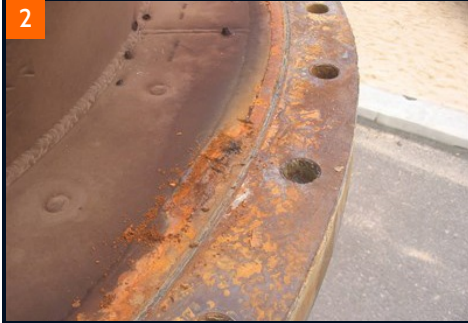
Galvanic corrosion between the cast iron of the discharge casing and the welded stainless steel sheet.
