# BELZONA REPAIRS BUCKET BOSS

ID: 5413

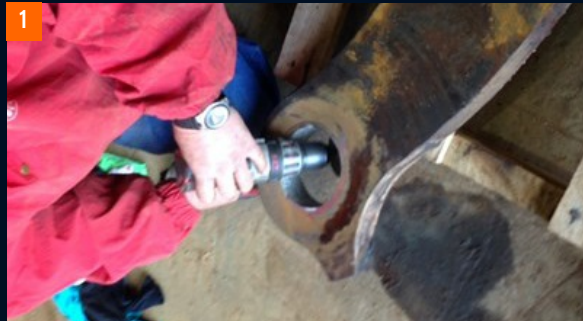
The bucket bosses were worn, causing the shaft to become loose and move. A loose fit causes faster wear and difficulties for the operator to be accurate.

1. Surface preparation
2. Close-up view of the bucket boss surface preparation
3. Completed application

A grinder and suitable cleaner/degreaser were used to ground down and clean the bucket bosses. They were then aligned on the bench and tack welded. Then, Belzona 9411 was applied to the shaft. Belzona 1311 was mixed and applied on the inside of the hole as well as the shaft. The shaft was then placed through the holes, making sure it was all pushed into the gaps, and wiped off the excess, then allowed to cure. They did the same for several more applications. Even 6 months later, the bucket boss has been working very well.
