# REPAIR CORRODED COOLING TOWER PIPE WITH BELZONA

ID: 5414

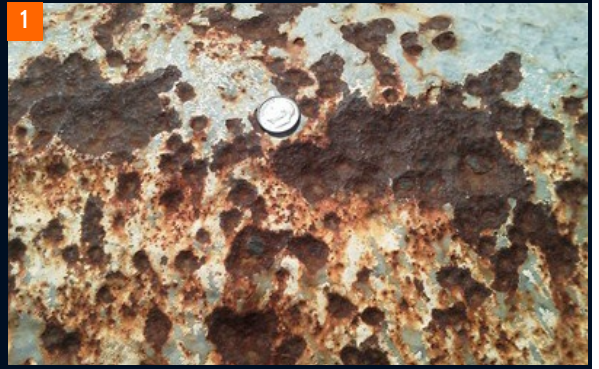
Non-destructive testing (NDT) showed where heavy corrosion had caused major pitting resulting in thin walled pipe in many areas and through wall in one spot.

1. Close-up of heavy corrosion
2. Original leak and new through wall due to blast
3. Belzona 1111 applied to fill the pits
4. Finished project
