# BELZONA REPAIRS AND PROTECTS PUMP CASING

ID: 5415

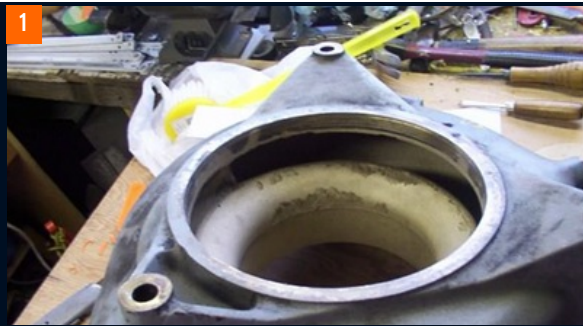
Pump casing was showing signs of degradation. This was from possible contamination during casting process.

1. View of casing showing damaged areas requiring rebuilding.
2. Application of 1st coat of Belzona 1341 in progress
3. Completed application.

A Belzona repair allowed the damaged areas to be quickly rebuilt and the casing protected from further bi-metallic erosion.
